# **3-YEAR ASBESTOS RE-INSPECTION REPORT**

## **NORTHEAST INTERMEDIATE SCHOOL SCRANTON, PA**

**SCRANTON SCHOOL DISTRICT  
425 North Washington Avenue  
Scranton, Pa. 18505**

PROJECT: #SSD.19\_751

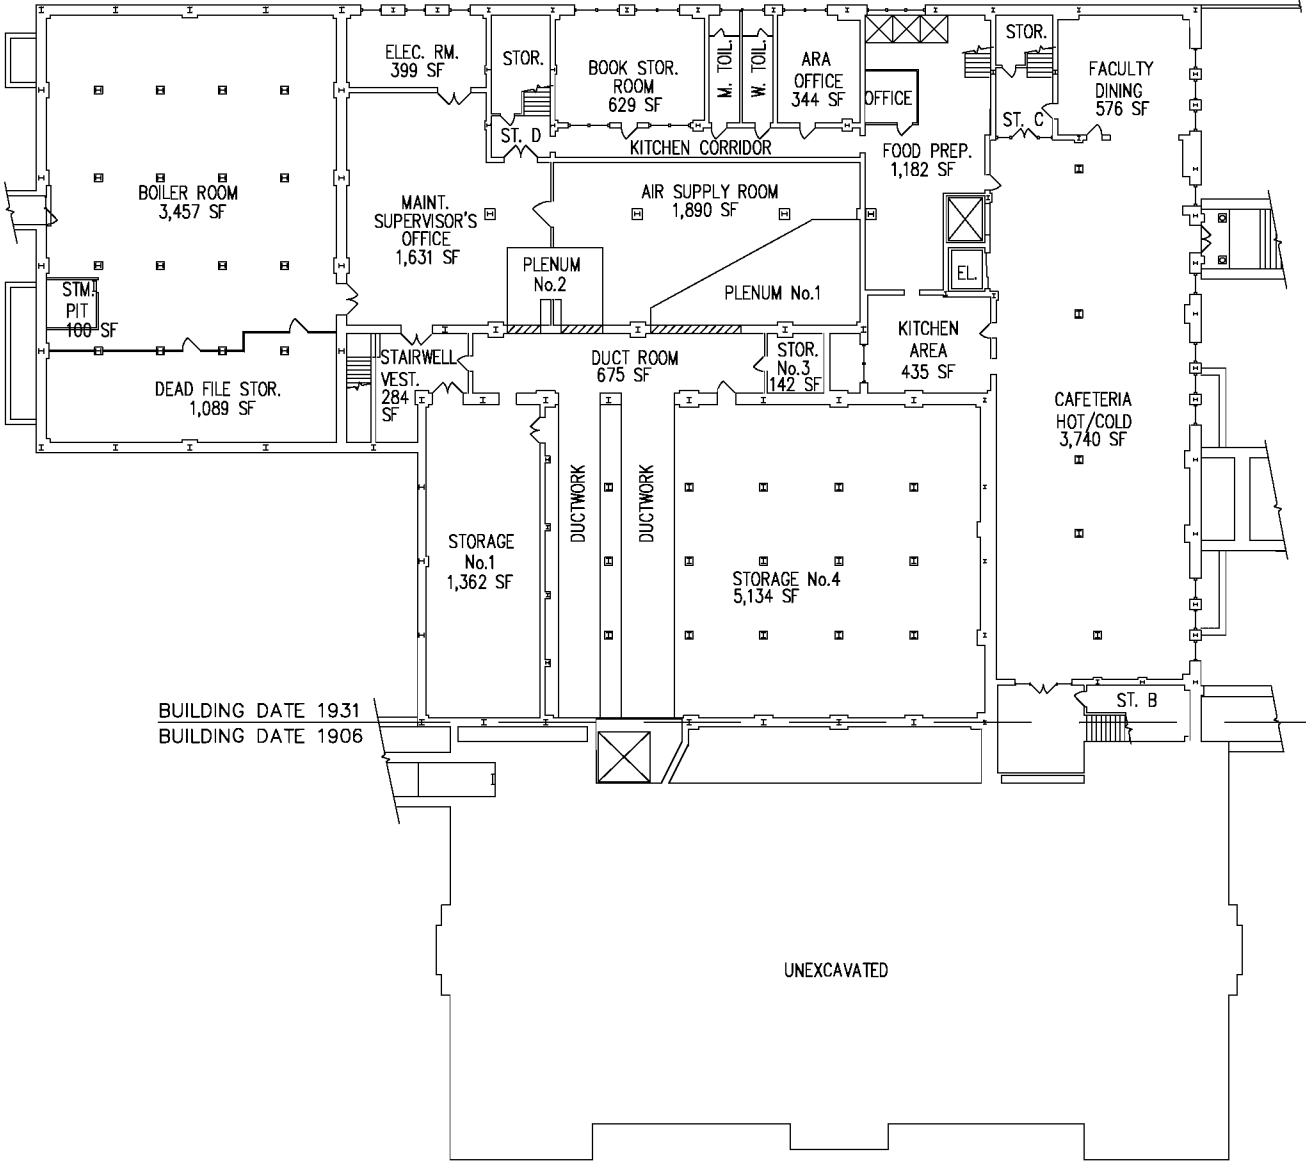
**BASEMENT FLOOR PLAN**  
NOT TO SCALE

NO SURFACING ACBM WAS  
FOUND ON THIS LEVEL

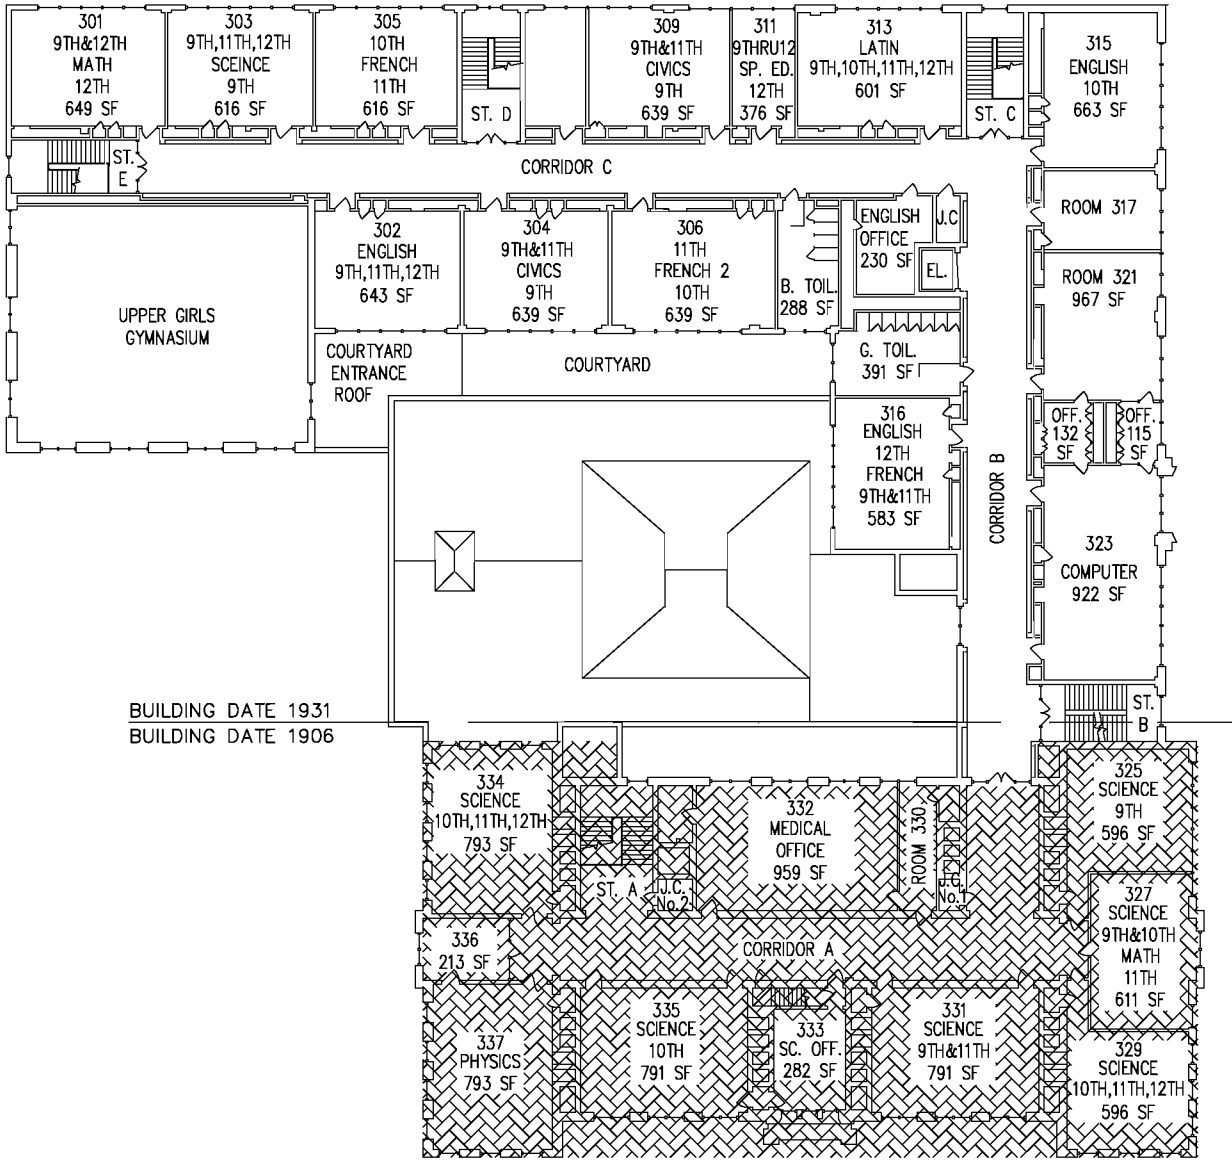
THIRD FLOOR PLAN  
NOT TO SCALE

PLASTER WALLS AND CEILINGS

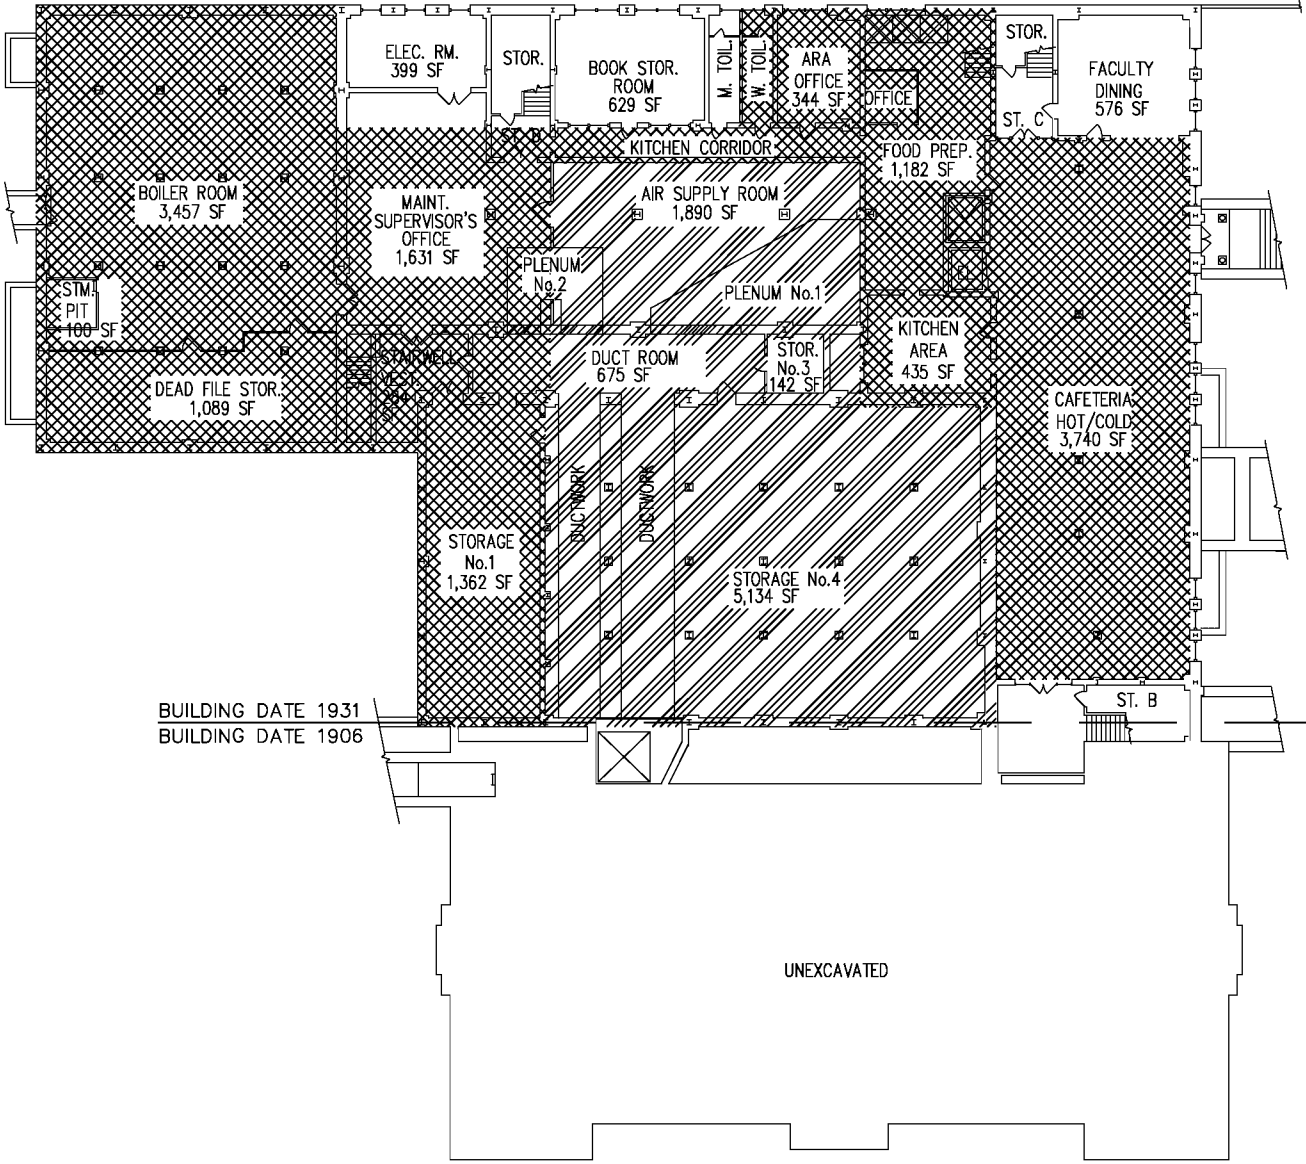
BASEMENT FLOOR PLAN  
NOT TO SCALE

CEMENTITIOUS INSULATION AND FITTINGS

CEMENTITIOUS INSULATION, FITTINGS, AND DUCTWORK INSULATION

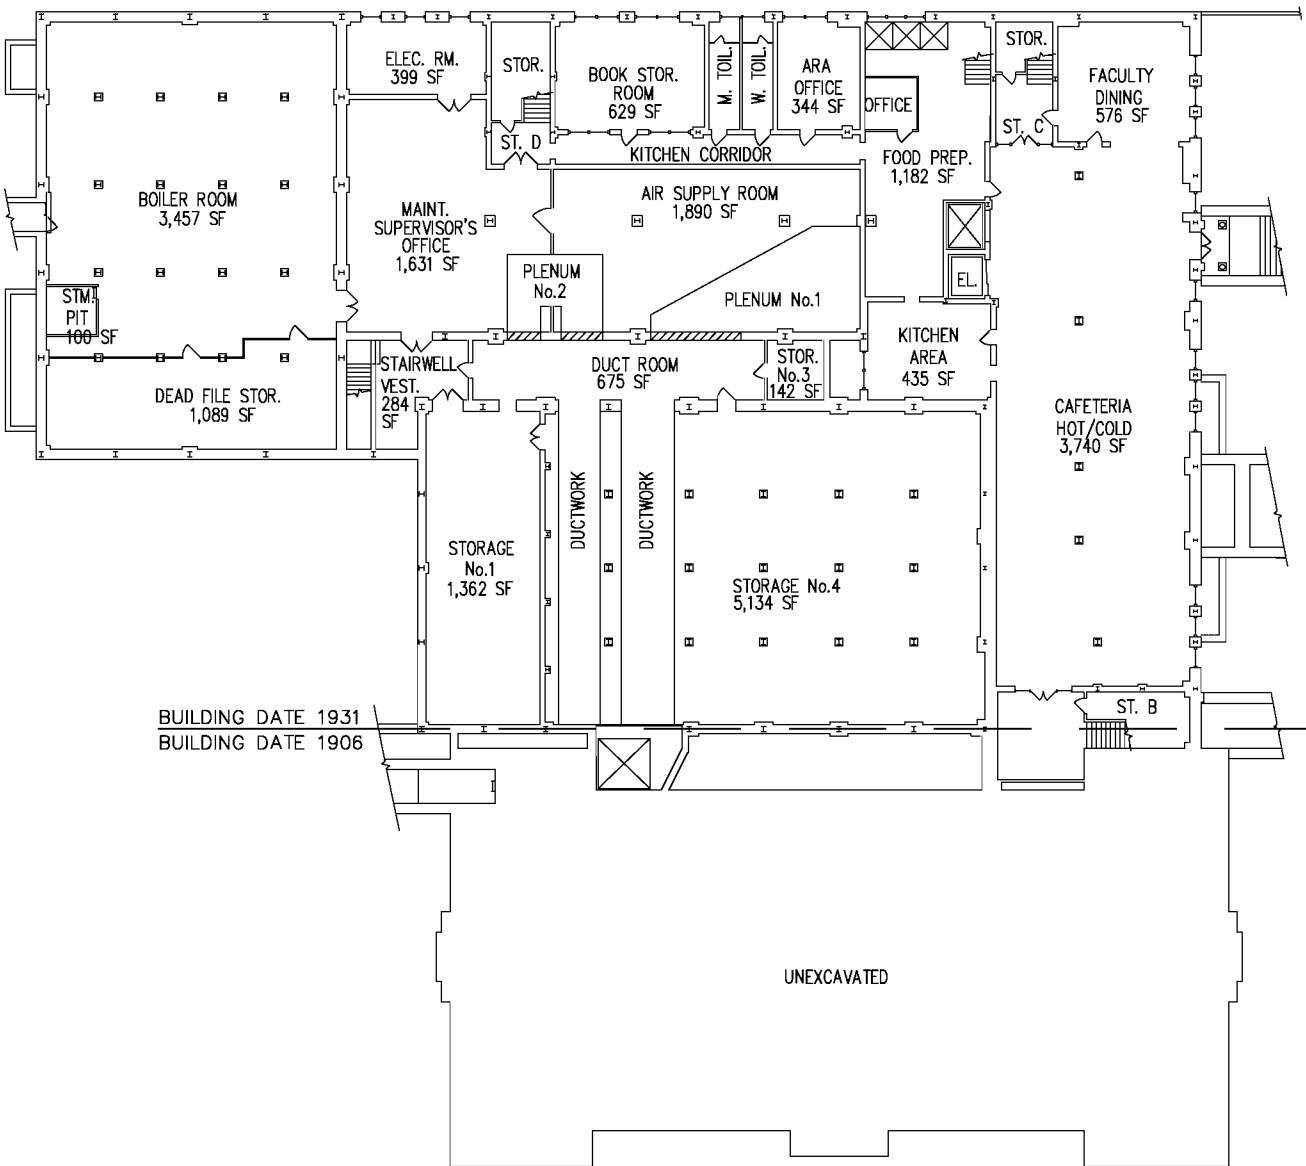
**BASEMENT FLOOR PLAN**  
NOT TO SCALE

KEY – MISCELLANEOUS ACM
ASSUMED ASBESTOS CONTAINING MISCELLANEOUS MATERIALS:
1. VAPOR BARRIERS (MAY BE PRESENT)

KEY – MISCELLANEOUS ACM 1906
ADDITIONAL CONFIRMED ASBESTOS CONTAINING MISCELLANEOUS MATERIALS:
1. INTERIOR WINDOW CAULKING
2. INTERIOR DOOR CAULKING
3. MARBLE MASTIC
ADDITIONAL ASSUMED ASBESTOS CONTAINING MISCELLANEOUS MATERIALS:
1. CHALKBOARD MASTIC
2. DUCTWORK FLEX CONNECTIONS
3. VAPOR BARRIERS (MAY BE PRESENT)

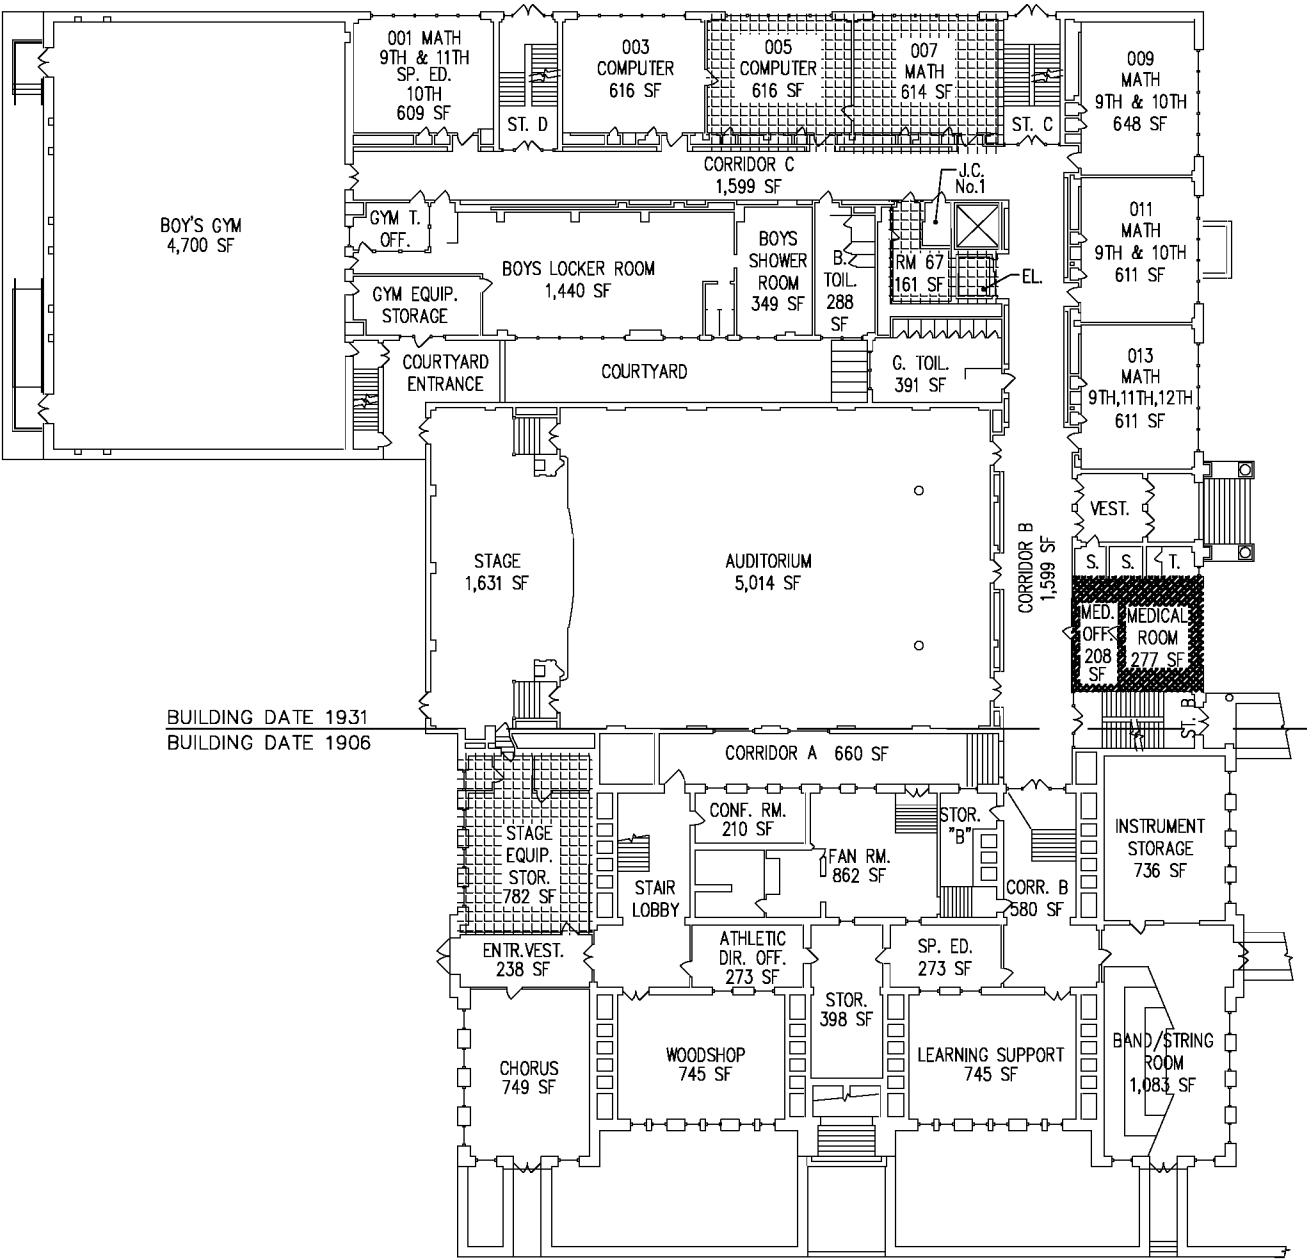
**GROUND FLOOR PLAN**  
NOT TO SCALE

KEY – MISCELLANEOUS ACM 1931
ADDITIONAL ASSUMED ASBESTOS CONTAINING MISCELLANEOUS MATERIALS:
1. CHALKBOARD MASTIC
2. DUCTWORK FLEX CONNECTIONS
3. VAPOR BARRIERS (MAY BE PRESENT)
